## What Happened?

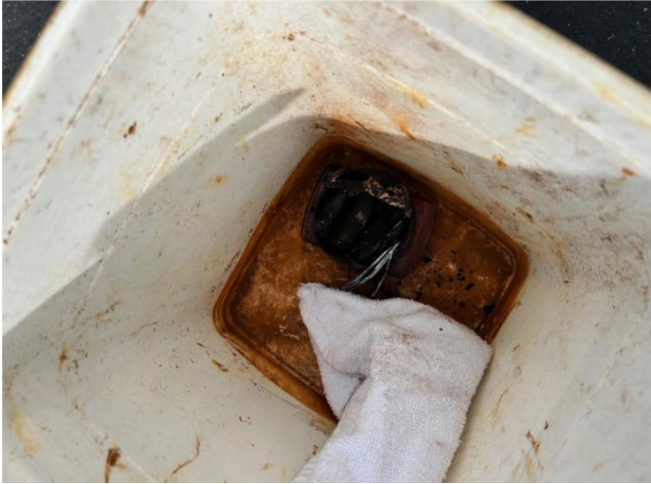
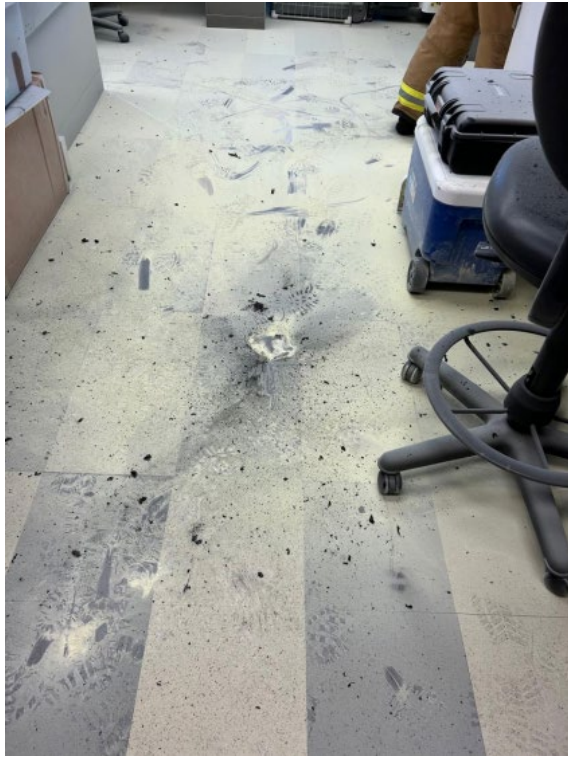
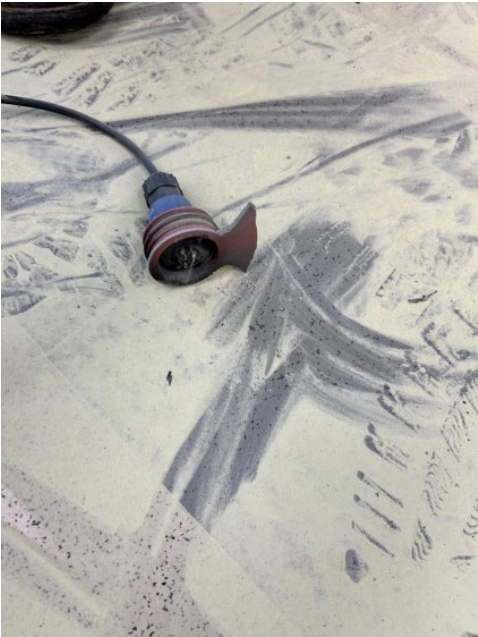
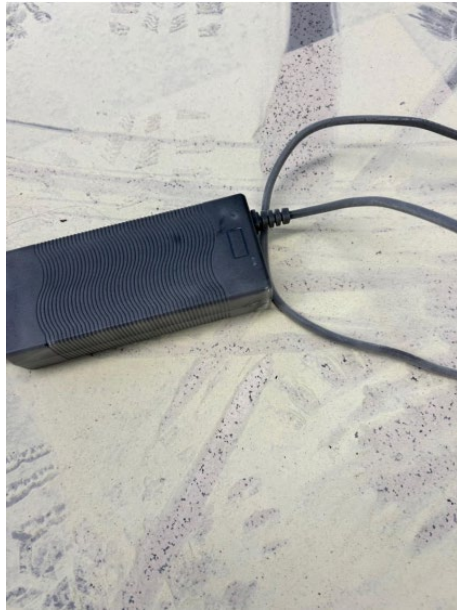
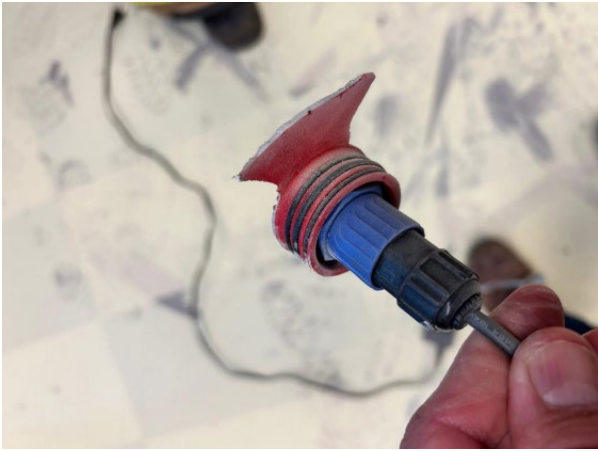
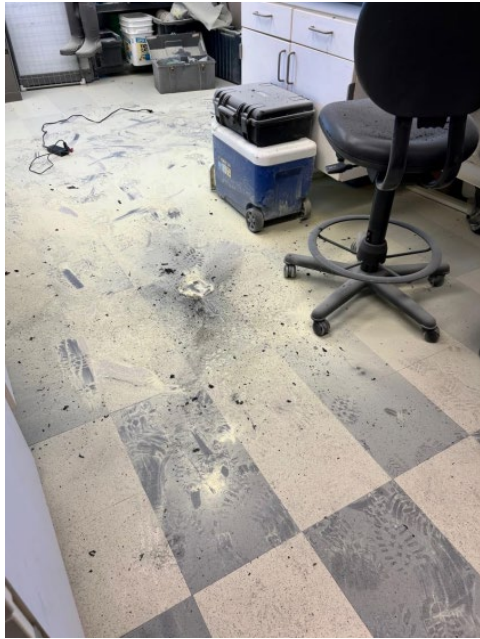
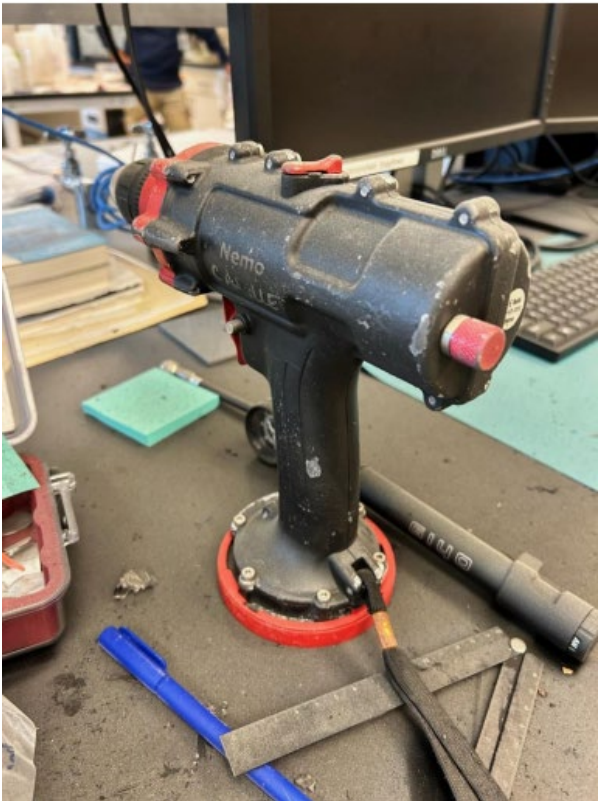
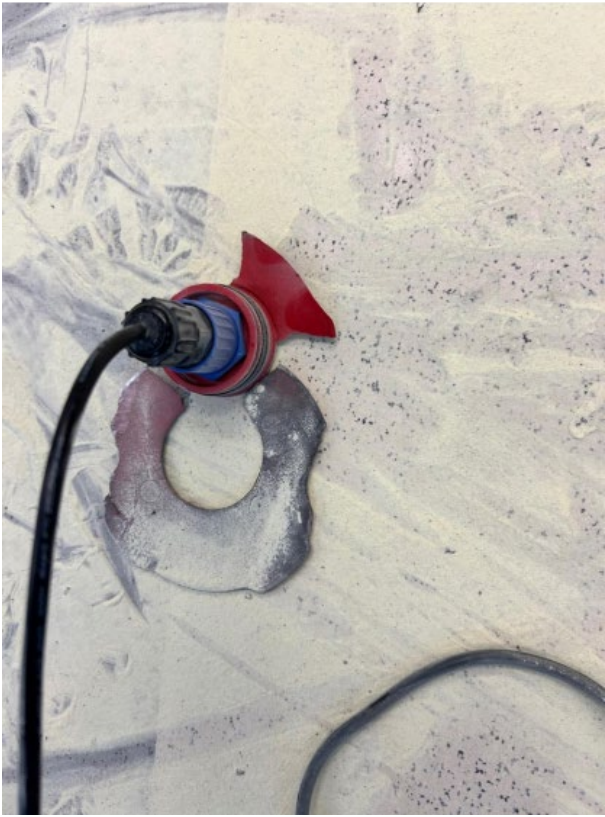
Photos:

Researchers were seated at their desks near the site of an explosion. They heard an abrupt, extremely loud noise and turned to find a battery on the floor with flames reaching approximately 1-1.5 feet high. The smoke triggered the lab's smoke detectors, subsequently activating the building's fire alarm systems.

One researcher quickly retrieved a fire extinguisher and put out the fire. However, the battery started popping again, reigniting the flames. They extinguished the second fire, closed the fire doors upon exiting, and left the building via the staircase. Firefighters arrived on the scene a few minutes later.

1. **Safety Equipment:** The lab will invest in fire and explosion-proof battery boxes for use during the charging of lithium batteries. This will help isolate batteries from personnel and flammable materials, adhering to Nemo Tools safety guidelines.
2. **Training:** Incorporate lithium battery charging safety discussions into the lab-specific training orientation. Ensure all lab members are knowledgeable about extinguishing small lithium battery fires using appropriate methods, which may include:

- ★ ABC or Class D fire extinguishers

- ★ Dirt or sand as smothering agents

- ★ Following manufacturer's guidance <https://nemopowertools.com/important-safety-instructions-for-nemo-chargers-and-batteries/>

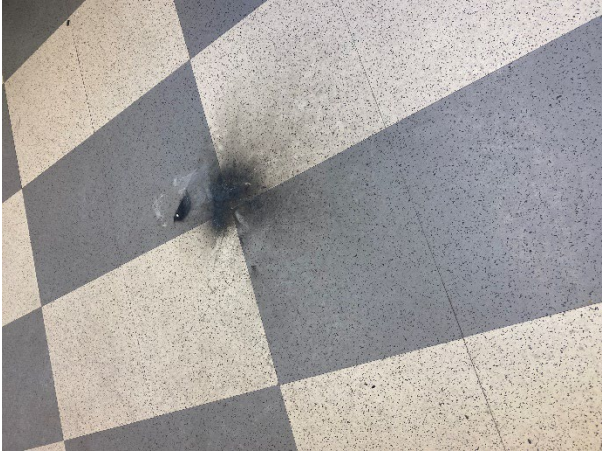
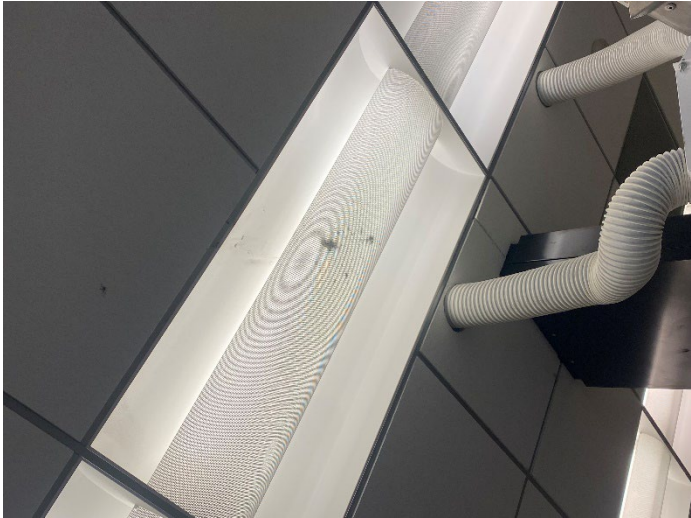
Photos: October 15, 2024. After cleaning; day of incident follow-up.
